INVESTIGATION OF IMMERSION SILVER PCB FINISHES FOR PORTABLE PRODUCT APPLICATIONS

Srinivas Chada and Edwin Bradley, III

APTC, Motorola, Inc

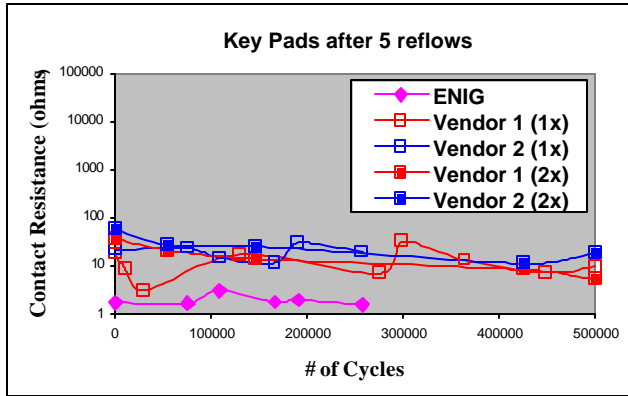
Figure 6. Keypad contact resistance data after 5 air reflows.

the radio is on the order of 25 kΩ or higher. Figure 6 illustrates the changes in contact resistance vs. # cycles of actuation of keypads for various surface finishes and subjected to 5 reflows prior to testing. As can be seen from the plot, all the samples are well below the arbitrary threshold value of 25kΩ even after 500,000 cycles of actuation. However, it is to be noted that the samples with ENIG are an order of magnitude or two lower in the contact resistance than the immersion Ag samples. Contact resistance values for samples treated to 5 reflows and exposure to 85°C/85 RH for 96 hours are shown in Figure 7. This graph too follows the same trend exhibited in Figure 6 with a slight increase in resistance, which is still far below the threshold of 25kΩ. Resistance measurements for samples subjected to 5 reflows and then exposed to mixed gas flow for 96 hours show a different trait (Figure 8). The resistance values for ENIG samples are unaffected while the immersion silver values start at higher resistance owing to corrosive layer on the surface (Figure 9), but decrease below the threshold of 25kΩ after actuation. This indicates that in

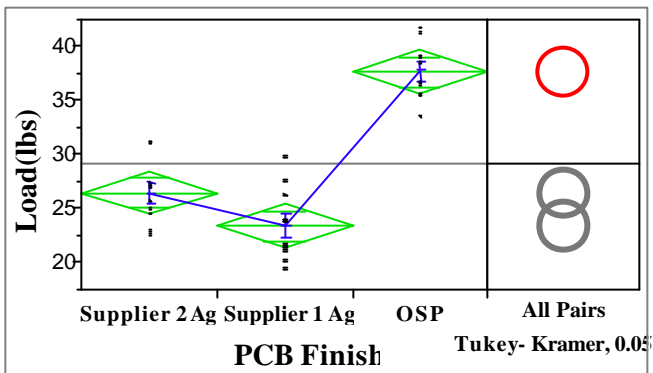
Figure 12. Maximum load at failure in 3 point bend test for various PCB finishes.

The maximum load at failure of 196 I/O GTBGA in three point bend test for various finishes is shown in Figure 12. The plot shows that the OSP samples fail at higher loads than both the immersion Ag finishes with the Ag finish from supplier 1 having the lowest reliability. Also, as seen from the Tukey-Kramer comparison circles reliability of Ag finish from both suppliers is significantly lower than that of OSP. A cross-sectional view of the failed samples revealed that the failure occurred at the PCB/BGA interface near the intermetallic layer as shown in Figure 13. Also, EDS quantitative elemental analysis confirms the same results that show Cu and Sn in proportions closer to stoichiometric values of Cu₆Sn₅ intermetallic (Figure 14). As addition of

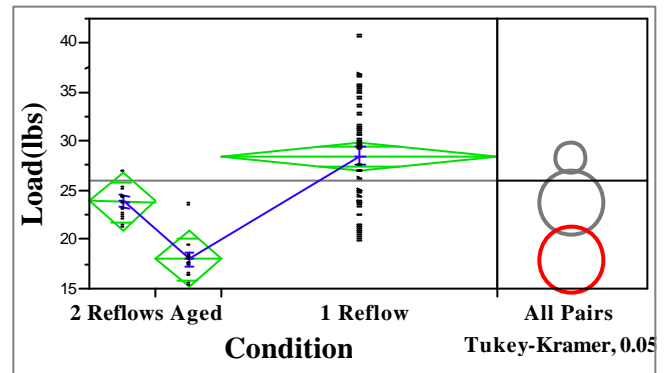
Figure 15. Plot of load to failure of Immersion Ag samples for various conditions tested in 3-point bending. Note the drastic drop in reliability for the aged samples.

Samples subjected to two reflows and aging of the solder joints lead to a lower reliability and is illustrated in Figure 15. This is probably due to an increase in intermetallic layer thickness⁹. Neither thickness of the Ag finish nor the peak reflow temperature has any significant bearing on the reliability. Figures 16 (a and b) and 17 respectively, illustrate this apparent lack of effect for the cases studied.

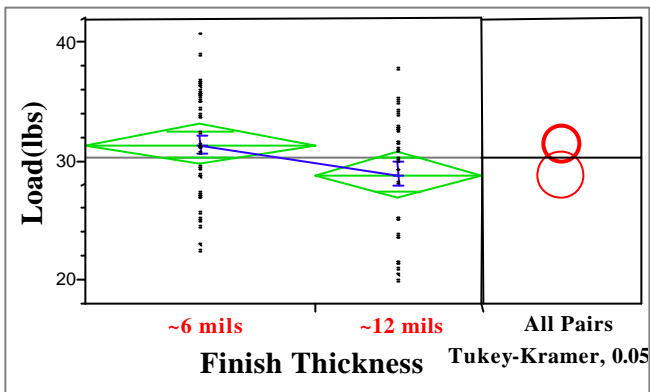
Figure 16b. Plot showing that the reliability of immersion Ag finish from Supplier 2 tested in 3point bending is independent of the finish thickness.

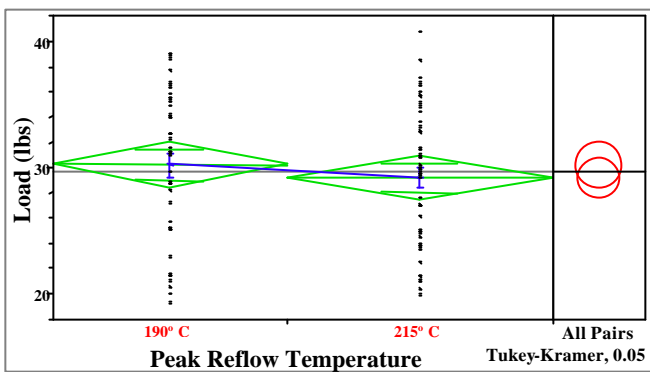
Figure 17. Plot illustrating that there is no significant effect of peak reflow temperature on the reliability of immersion Ag finishes tested.

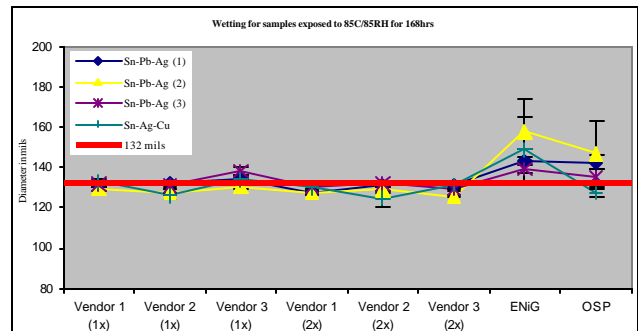
Figure 19. Wetting data of Sn-Pb-Ag and Sn-Ag-Cu solder pastes over various surface finishes exposed to 85°C/85RH for 168 hours.

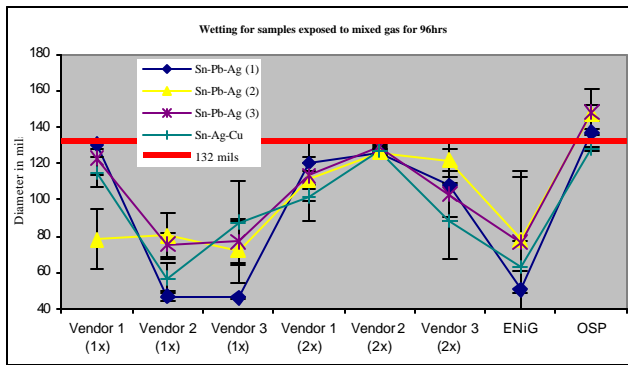
Figure 21. Wetting data of Sn-Pb-Ag and Sn-Ag-Cu solder pastes over various surface finishes exposed to flowing mixed gas for 96 hours.

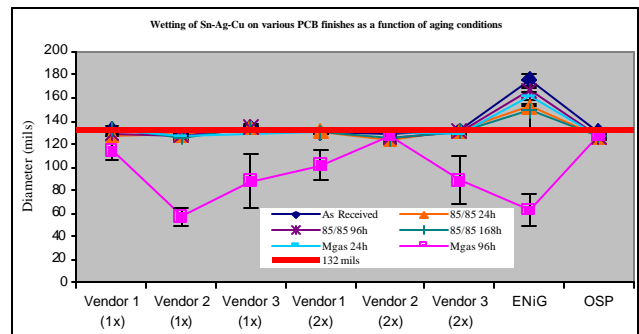
Figure 26. Wetting data of Pb-free paste Sn-Ag-Cu on various PCB finishes as a function of aging conditions.
